MEZ-AEROSEAL

# Donau center

» Sealing of four existing exhaust air ducts (ABL) to achieve tightness class C, so that the requirements of ÖNorm H6030 and EN 16282 can be met«

**Location:** Vienna, Austria  
**Date:** Mai 20  
**MEZ-AEROSEAL Partner:** Aeroseal Austria GmbH  
**Executing company:** Herbsthofer GmbH

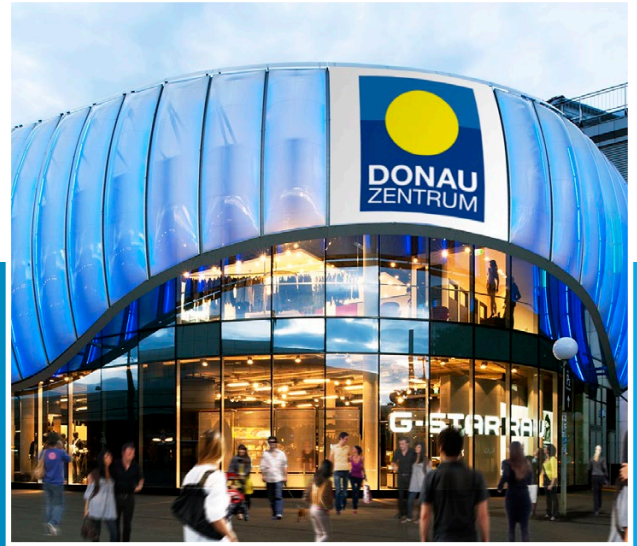
**Result:** In the course of the modernization of the Donau Zentrum and the construction of new restaurant areas, the four exhaust air pipes leading over the roof were also to be cleaned and sealed in case of leaks. HBL Haidinger carried out the cleaning of the existing lines and thus ensured that the fire load was considerably reduced, because the massive grease residues that had accumulated in the lines over time were removed. This was followed by a tightness measurement by Herbsthofer. For this purpose, all air pipe connections in the area of the roof valve gates were closed with metal plates and the measuring device, which can also be used as a sealing device, was connected to the four existing lines. The result: a leakage rate of almost 550 l/s. In order to eliminate this reliably, but without having to intervene in the freshly constructed building fabric, the Aeroseal method was used for sealing. Within a short period of time, the leakage rate was reduced by 99.6% to just 2.2 l/s, thus achieving the desired air tightness class C for all four lines.

Before sealing	After sealing	Reduction
• 534,3 l/s at 300Pa	• 2,2 l/s at 300Pa	• 99,6%
