## **IST METZ GmbH**

**MEZ-AEROSEAL** MEZ-TECHNIK GmbH

IST METZ Group in Germany erected a new production site with a total surface of 4900 m<sup>2</sup>. The duct systems in the ground floor and the second floor didn't meet the tightness class specifications. They were sealed with MEZ-AEROSEAL in one day..

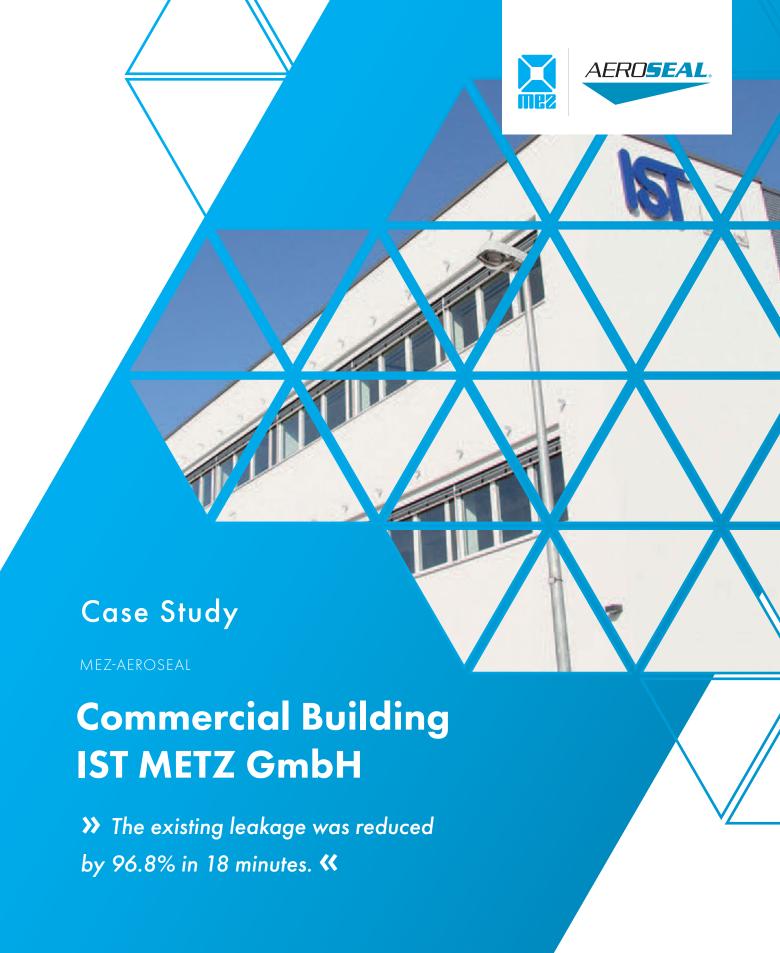
Result: The two sealed duct systems were for supply and return air. The injections for both

sealing events were performed on the roof due to the good accessibility. The injection time of both sealing events was 18 min and the results were quite remarkable.Leakage was reduced by 96,8 %. The owner of the building as well as the participants of the AEROSEAL live demonstration were really impressed by the result, efficiency and

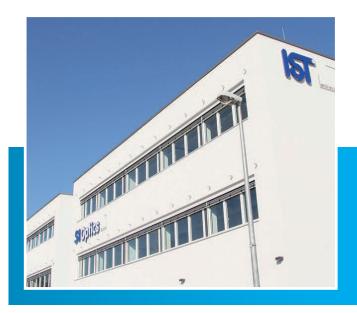
## The change in leakages

Before sealing

• 130,3 l/s

After sealing

• 4,2 l/s

Reduction

• 96,80%
