## Case Study

MEZ-AEROSEAL

Lux Tower

» Compliance with tightness class C. ≪

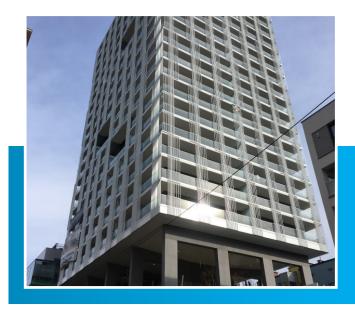
In the recently constructed multi storey building, a rental area was converted into a restaurant. The existing ventilation unit was replaced. However, with the existing ventilation ducts it was not so easy. In order to prevent odour nuisance, the standard ducts that had been constructed were additionally sealed with the Aeroseal system, as another renovation option was not practical due to accessibility and cost. The ABL and FOL ducts of this system now have the tightness class "C" and thus meet the requirements regarding tightness.

Location:	Linz, Österreich
Date:	Dez 19
MEZ-AEROSEAL Partner:	Aeroseal Austria GmbH
Executing company:	Aumayr GmbH Lüftung und Metalltechnik
Result:	The air duct connections on the ventilation unit were closed off with sheet metal plates. Similarly, the new air ducts installed in the restaurant were sealed with sheet metal pla- tes from the existing ducts in the shafts. The sealing unit was installed directly below the ventilation ducts in the area of the bicycle storage and connected to the ventilation

with the Aeroseal system, a tightness class "C" was achieved for these ventilation ducts.

ducts above. After sealing was completed
